Manhole Inspection Summary

Manhole # S41QQ_020MH

Insp Date: **2/20/07 1:54 PM**

Location Address: **1001 25TH ST**

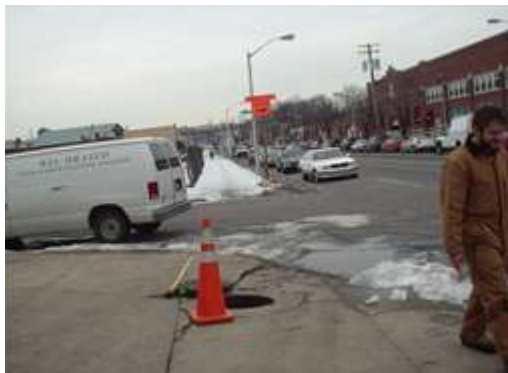
Location View

Cracks around the MH

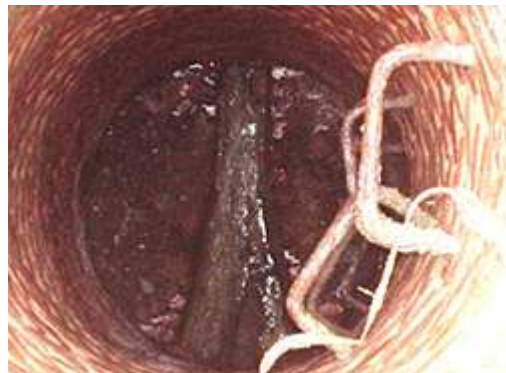
Top View

Corroded and missing steps. Bench debris.

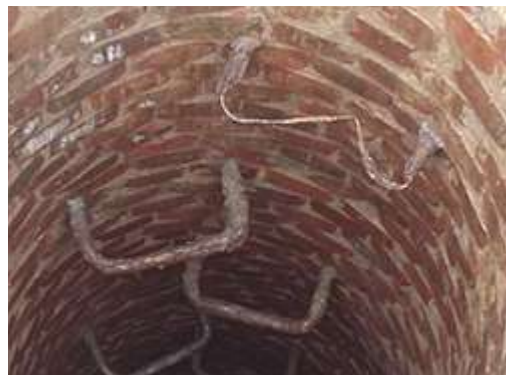
Defect

Condition: ☐ Sound ☐ Cracked ☐ Root Intrusion ☐ Loose Brick ☒ **Deteriorated**

Infiltration: ☐ None ☒ **Joint** ☐ Cracks ☐ Mortar ☐ Roots ☒ **Wall**

Infiltration: ☐ None ☐ Joint ☐ Cracks ☐ Mortar ☐ Roots ☒ **Wall**

Adjustment and Barrel infiltration.

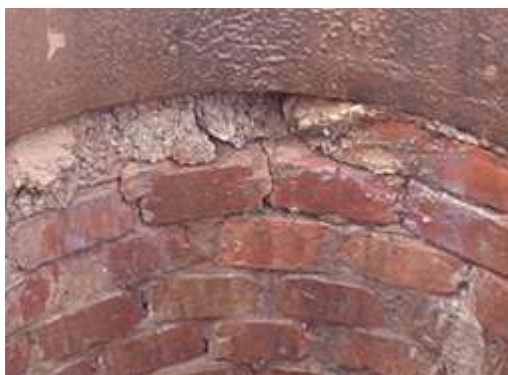
Defect

☒ **Leaks**

Frame leaks. Adjustment deterioration and infiltration.

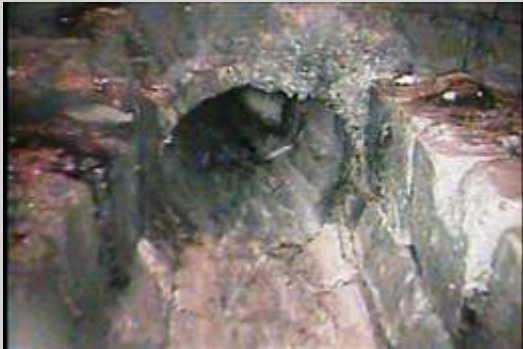
8 in. Circular Gravity Sewer Pipe Out @ 12 O'Clock

Channel deterioration.

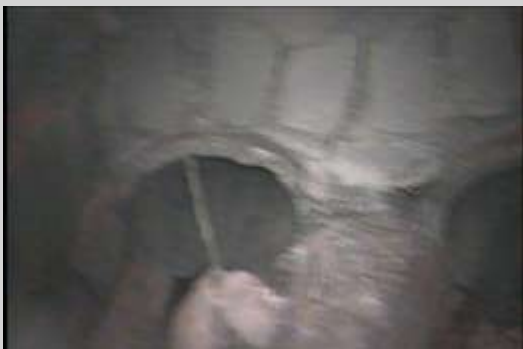
6 in. Circular Gravity Sewer Pipe In @ 5 O'Clock

Deposits: ☐ None ☐ Mud ☐ Sludge ☒ **Debris** ☐ Grease

Silt Depth: **0** (in.) Deposits Extent: **Light**
